**Asbestos Abatement Work Plan
Former Gas Administration Building,
25 Cimino Drive/101 Conejos
Colorado Springs, Colorado**

WALSH Project Number: 900586.0001.010
November 4, 2009

**ASBESTOS ABATEMENT WORK PLAN
FORMER GAS ADMINISTRATION BUILDING
25 Cimino Drive/101 Conejos
COLORADO SPRINGS, COLORADO**

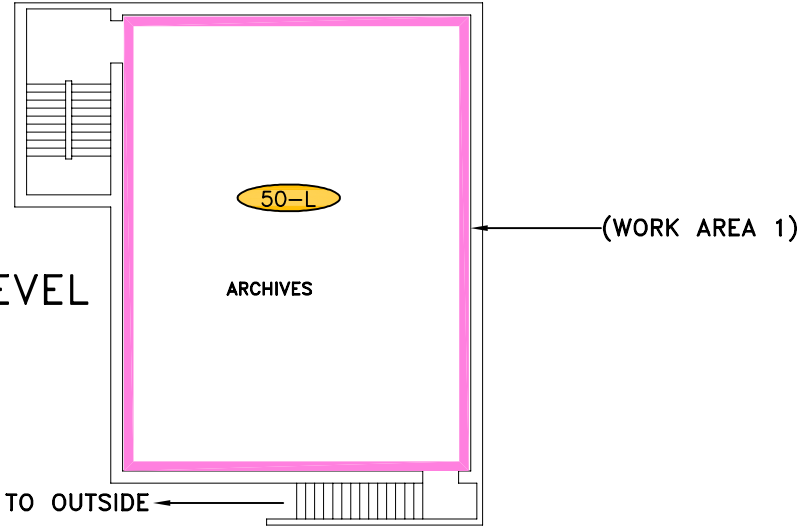
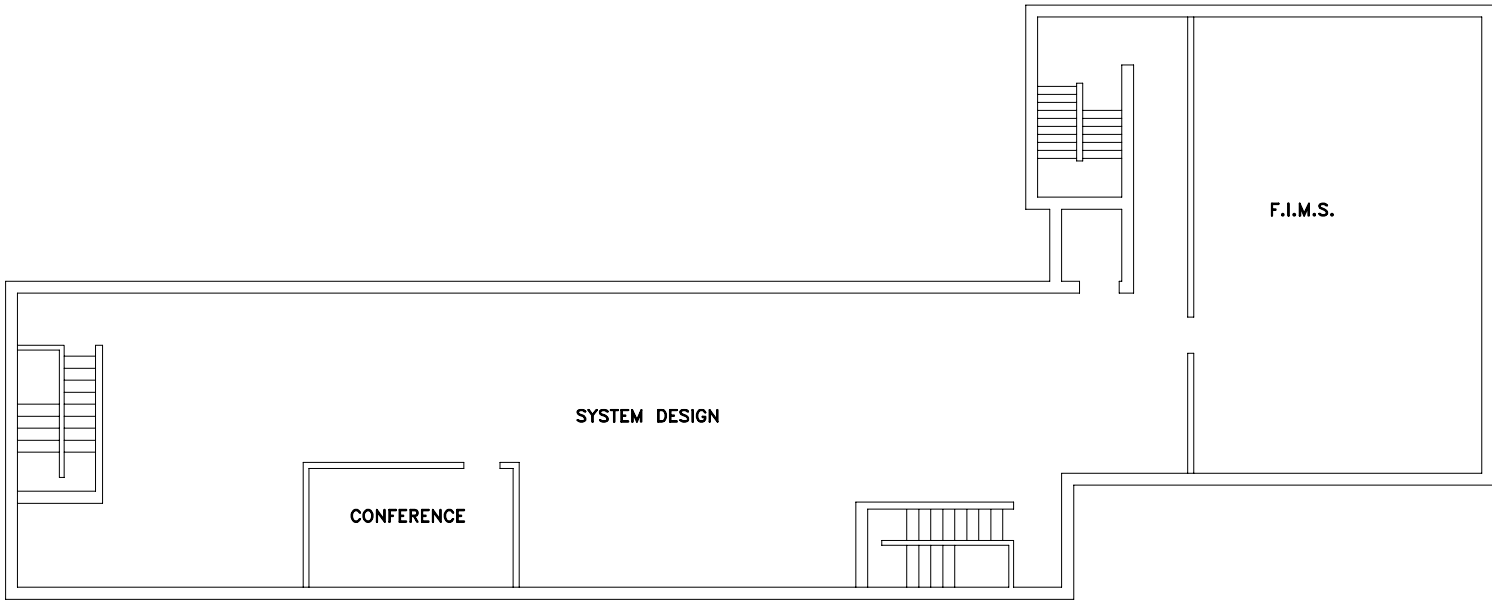
Job: 900586.0001.010	Date: 10/09	Figure: 1
----------------------	-------------	-----------

**ASBESTOS-CONTAINING MATERIALS FOR REMOVAL
FORMER GAS ADMINISTRATION BUILDING**

LEGEND:
ACMs IDENTIFIED TO DATE:
6-L - THERMAL SYSTEMS INSULATION (WORK AREA 1)
TSI - (PIPES AND ELBOWS)
NUMBER = QUANTITY OF ELBOWS

Figure 1	Work Area 1
Figure 2	Work Area 2

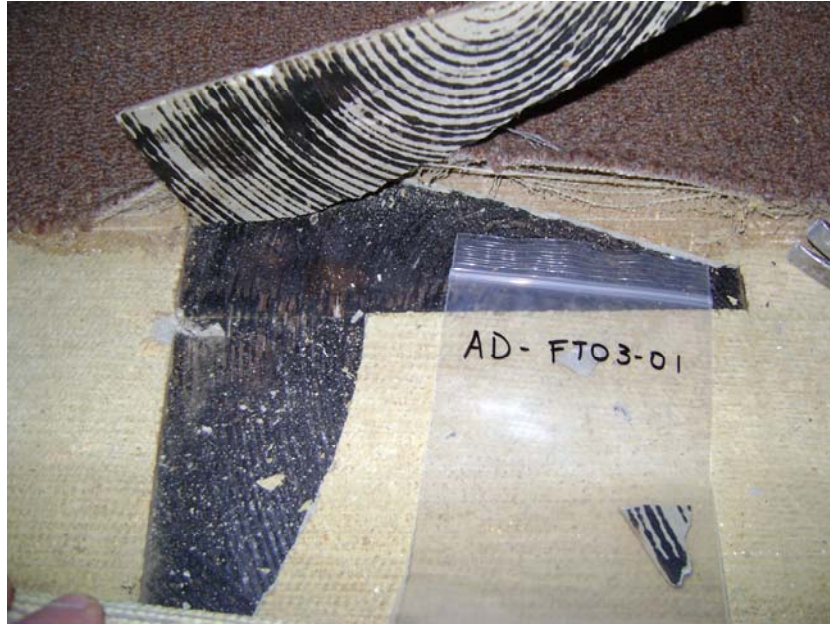
Photo 1 – View of gray floor tile containing 17% Chrysotile.

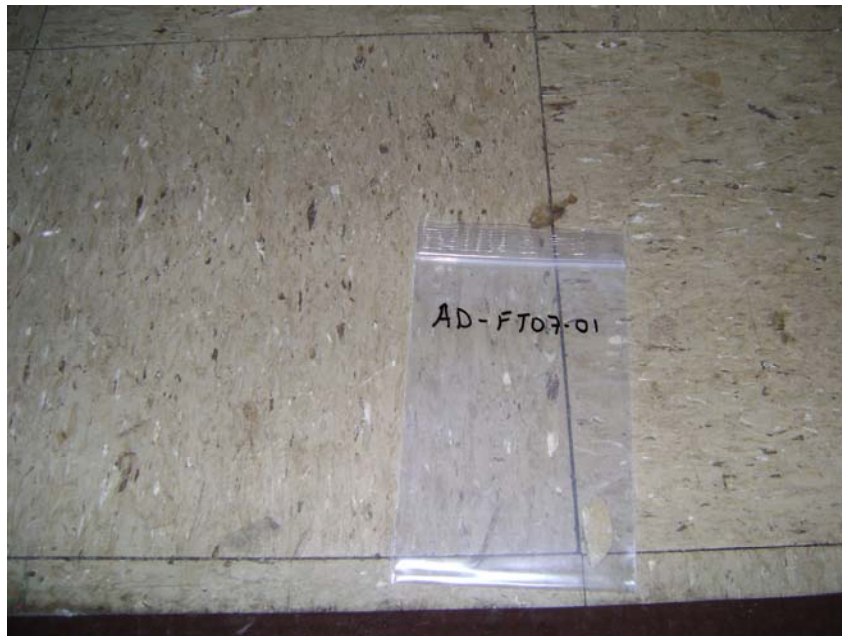
Photo 2 – View of brown floor tile containing 4% Chrysotile.

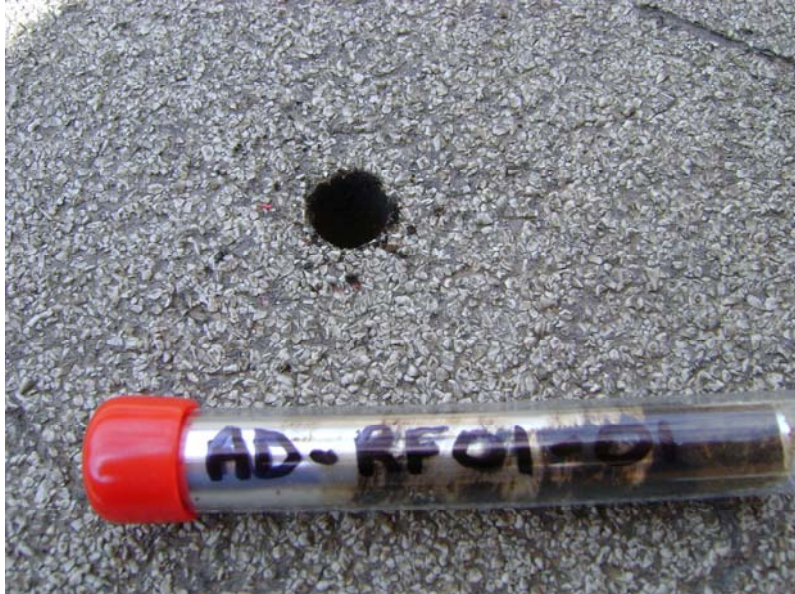
Photo 3 – View of roofing shingles containing 15% Chrysotile.

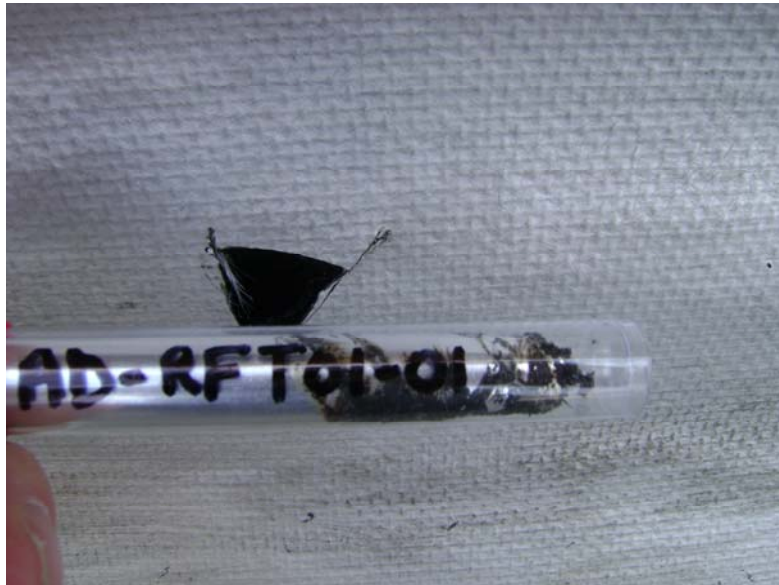
Photo 4 – View of roofing tar and felt containing 20 % and 10% Chrysotile respectively.

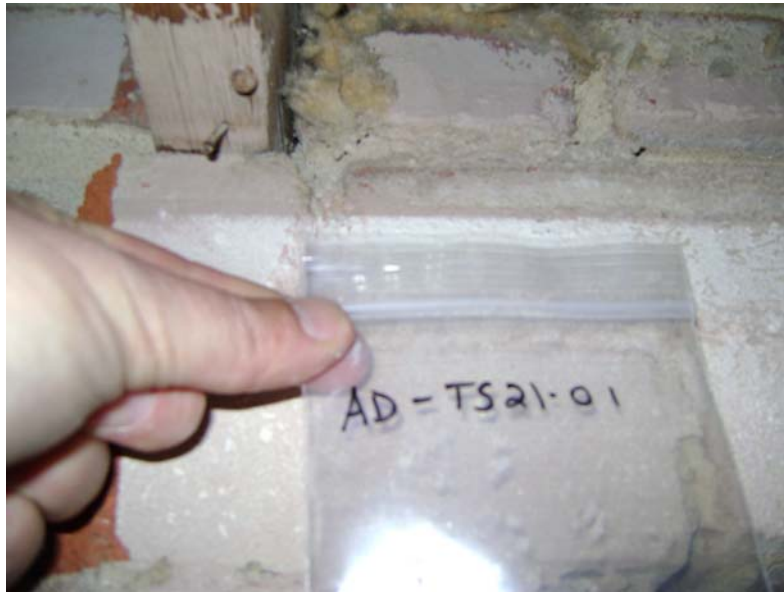
Photo 5 – View of ceiling texture overspray on wall containing 3% Chrysotile.

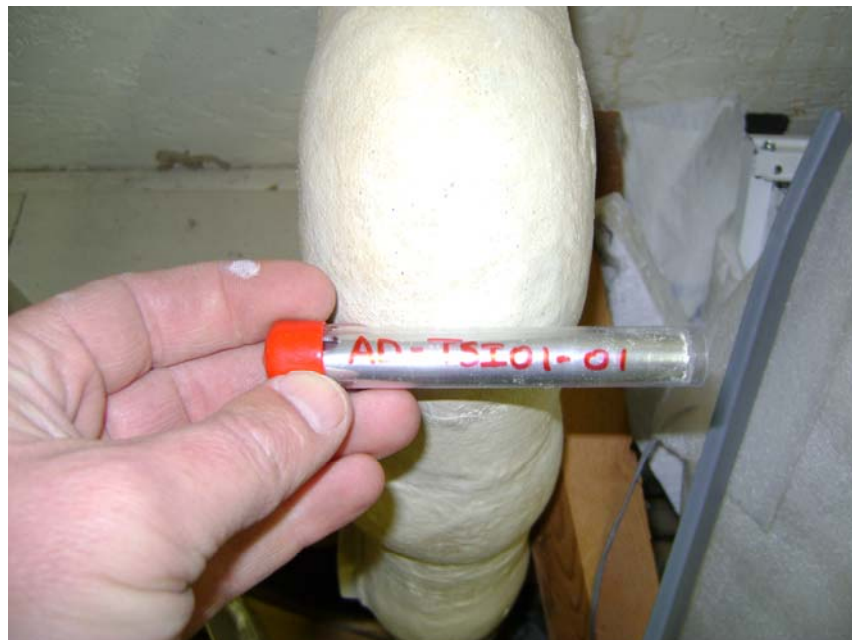
Photo 6 – View of hard-packed pipe fittings containing 8% Chrysotile.
